NRL/MR/6120--97-7957

Control of Lead in Drinking Water

13. ABSTRACT (Maximum 200 words) This report describes the installation of an NRL-developed epoxy lining in the drinking water distribution system in three buildings. Water was sampled before and after installation of the lining; the sampling data was interpreted after several confounding factors were identified and allowed for. Improper installation of the lining in one of the buildings led to its premature failure, and this was documented and analyzed. The lining is shown to be effective in preventing leaching of lead into drinking water. This technology is recommended as a routine method for excluding lead from drinking water distribution systems in buildings, and guidance for use in establishing contracts to install the lining is provided.

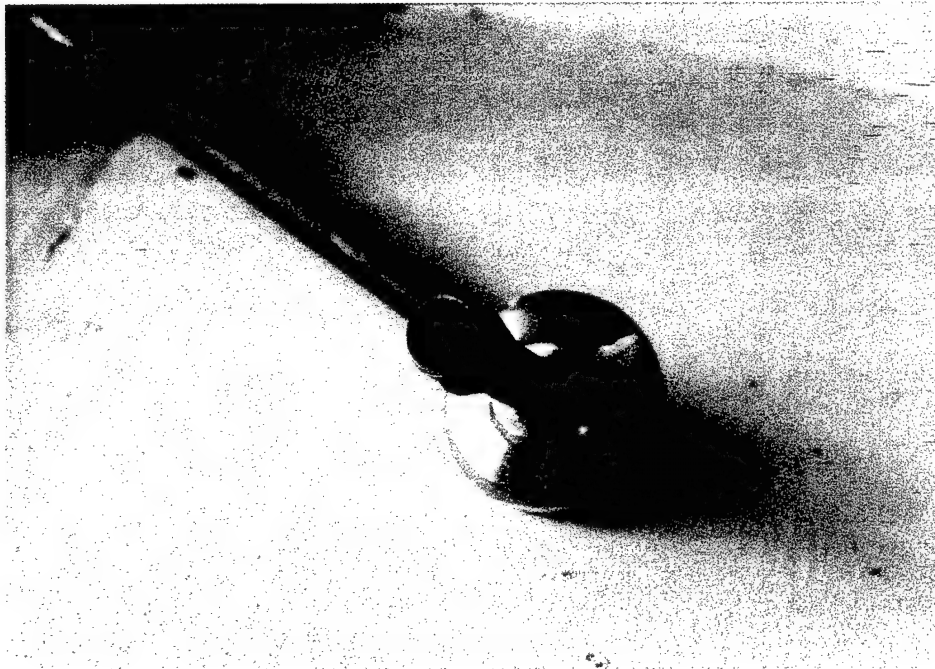
Some of the feed lines to bathroom taps were blocked with debris. Figure 3 shows the hot water line just behind the tap in room 214; this debris was packed hard and more than 3/4" deep.

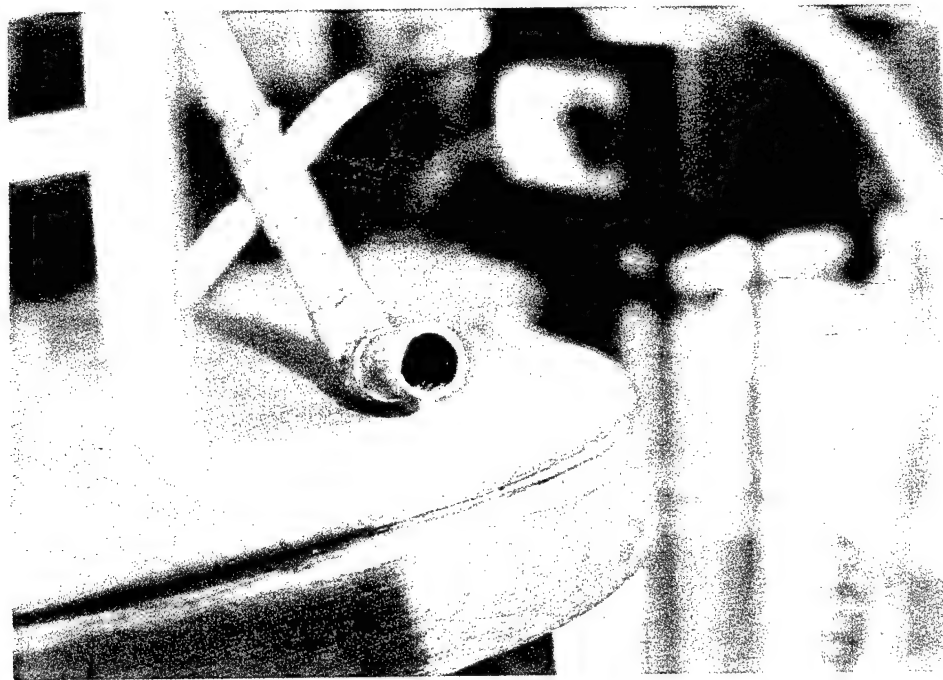
Figure
8

but 24 inches toward the main there is no coating at all (Figure 8). The cold water line (Figure 9) to the ladies room near the first-floor lobby and to room 207 was at the upper limit of thickness on the bottom and very rippled.

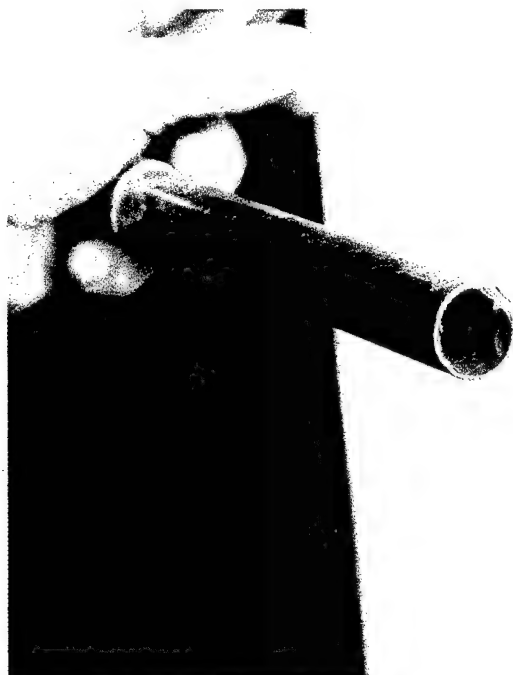
Figure
10

The hot water line leading to laundry on the first floor between room 107 and the booking office showed good adhesion, but the paint is excessively thick and severely rippled (Figure 10). The lining in the hot water pipe to room 106 (Figure 11) was at the maximum permissible thickness and showed ripples, good adhesion, and some evidence of grit in the paint.

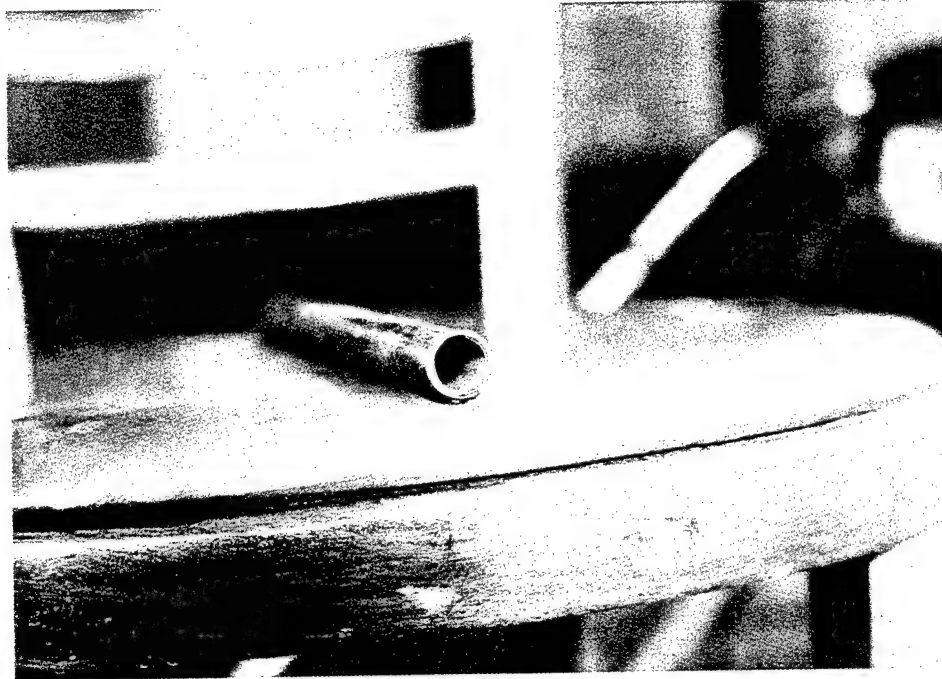
Figure
12

The lining in the cold water feed to room 105 (Figure 12) was excellent, showing proper thickness, good adhesion, and no contamination. Lining in the hot water line into room 101 was hard and smooth, adhered well, but was slightly thick on the bottom of the pipe nearest the tap (Figure 13).

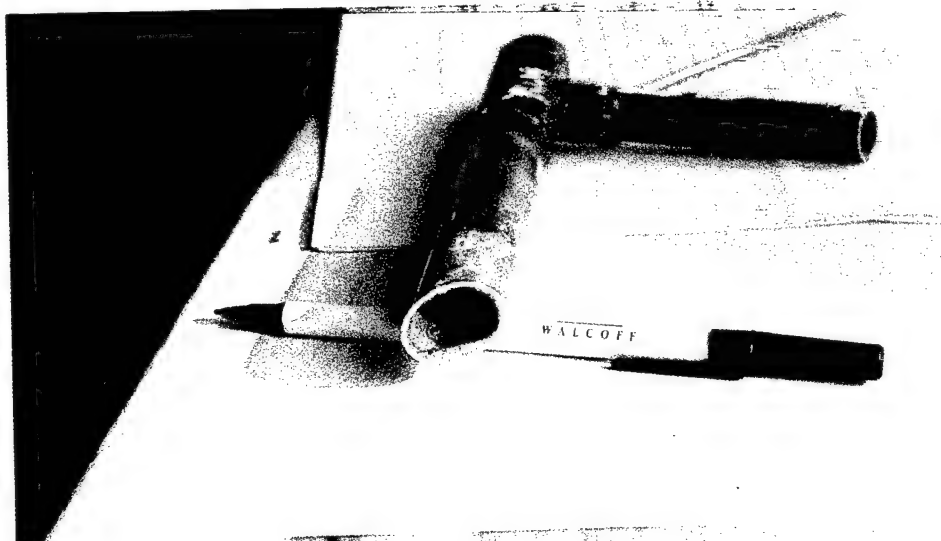
Figure
14

Workmanship in the cold water main is good at the north end but very poor at the south end. At the north end, the lining is generally smooth and glossy, with light rippling. Adhesion of the paint seems satisfactory. The paint is thicker on the bottom of the main at the north end of the building (Figure 14), but not so thick as to obstruct flow.

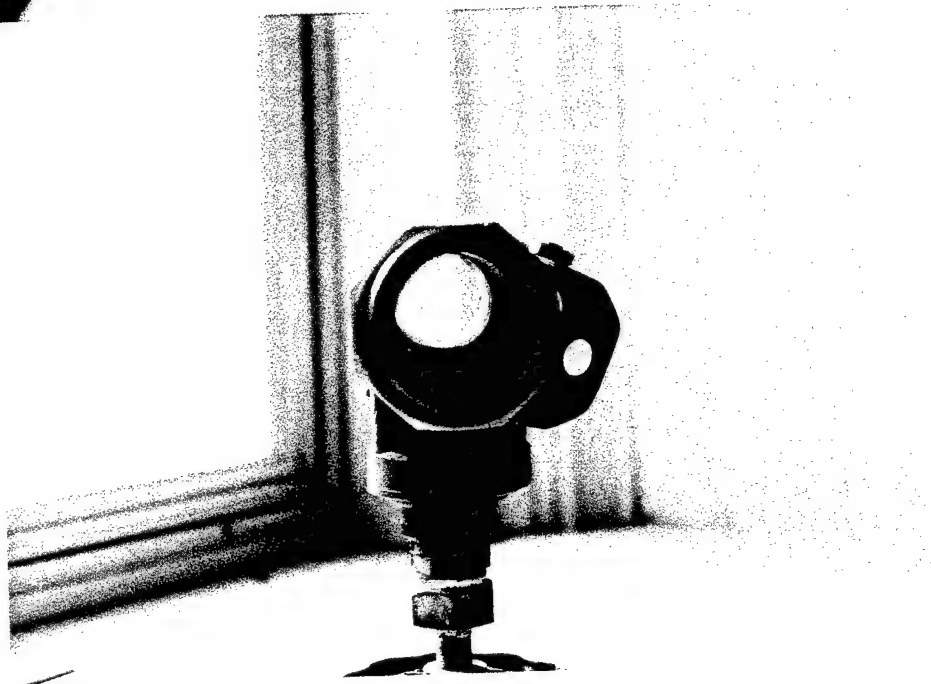
Figure 15 shows a valve and adjoining piping from the cold water main at the north end. The valve is operable but must pierce and crack paint in order to close. The coating is generally smooth, with light rippling but no blisters. Adhesion of paint seems satisfactory. Paint has a matte finish instead of the normal gloss.

All valves were painted, and most were inoperable (see Figures 15, 17 and 20 above). The contract explicitly required valves to be removed from the lines before painting.

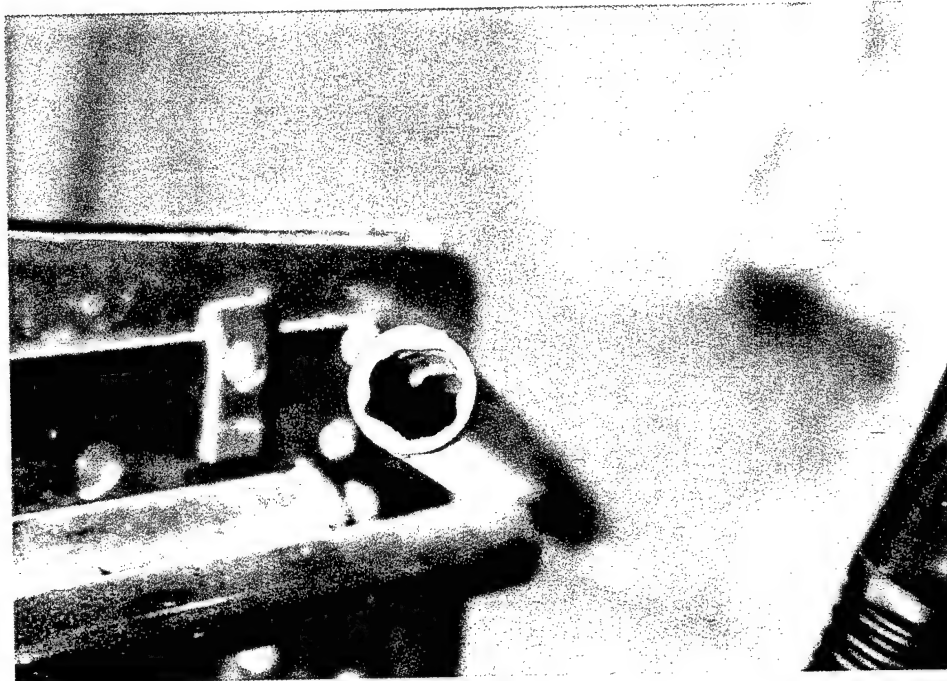
Figure
16

At the south end of the building, the paint is excessively thick and rippled (Figure 16). A valve in this line is painted open and cannot be operated (Figure 17).

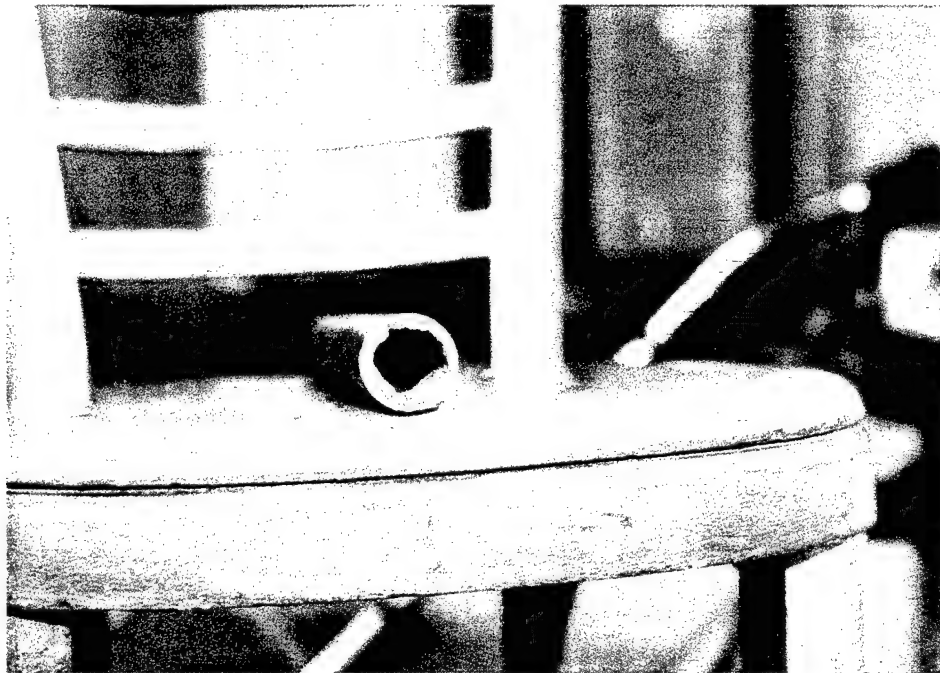
Figure
18

At the far south end of the building, the lining is excessively thick at one point, but stops abruptly leaving uncoated pipe. In a section of 1" cold water main from far south end of building, the paint is excessively thick at one end (Figure 18) but there is no paint at all at the other end (Figure 19). The roughness of the pipe surface at the uncoated end is very light on the bottom and sides, but there is no roughness at all on the top 60° of the pipe.

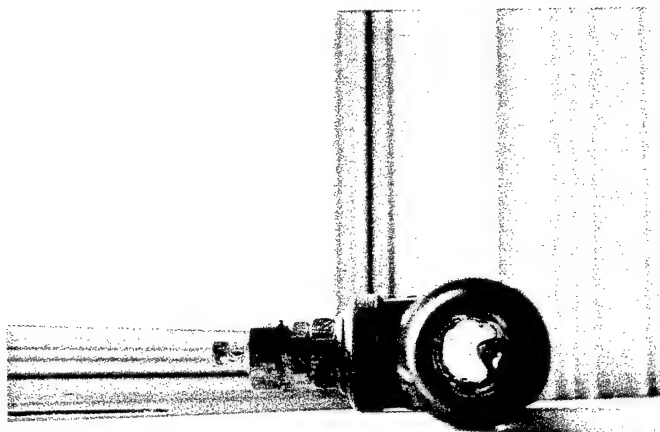
Figure 20 shows a section including a valve from the hot water main at the north end of the building. The thickness of paint in the pipe is acceptable, but the valve is painted open. A single blister about 8" long has formed at the top of the pipe. The interior metal surface of pipe is very smooth; there is no surface roughness at all.

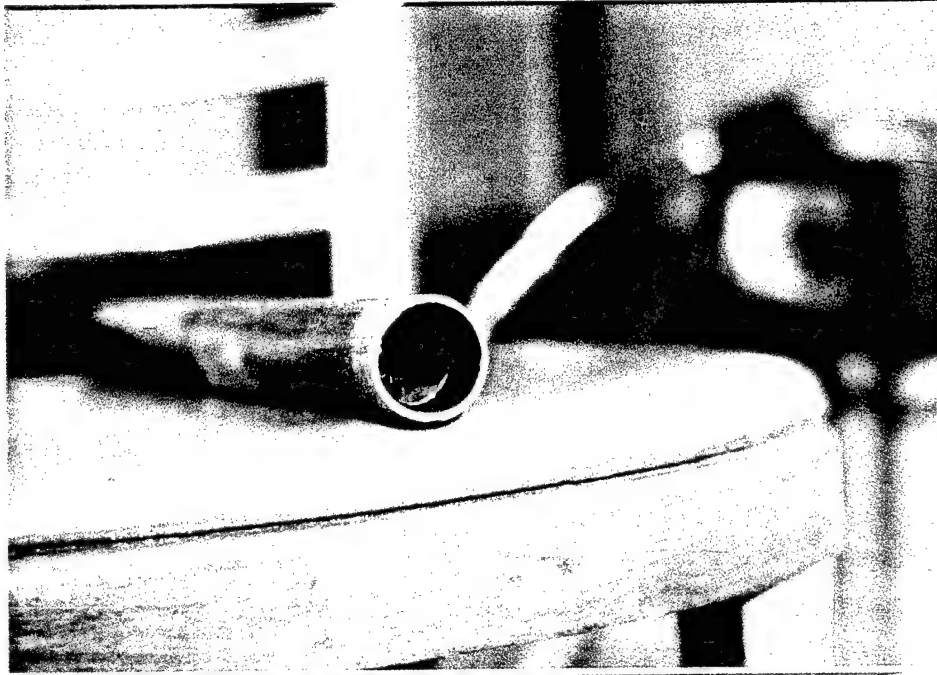
Figure 22 shows a section of pipe from the south end of the building. Adhesion to the bottom of the pipe is satisfactory, but paint on the sides and top of the pipe has lost adhesion to the metal and moved into the center of the pipe, where it may be broken loose by flowing water.

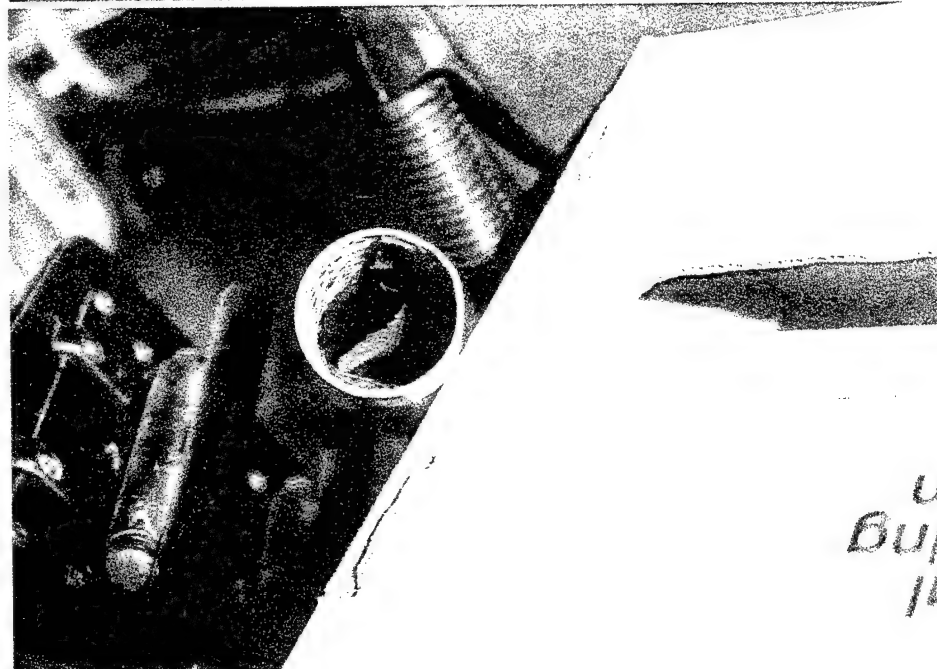
Figure 23 shows delamination of paint, leaving bare metal and flakes partially obstructing flow in hot water 2" pipe from ceiling in main hallway at south end of the building. The mottled black spots on the metal indicate that hot work has been done close to this site.

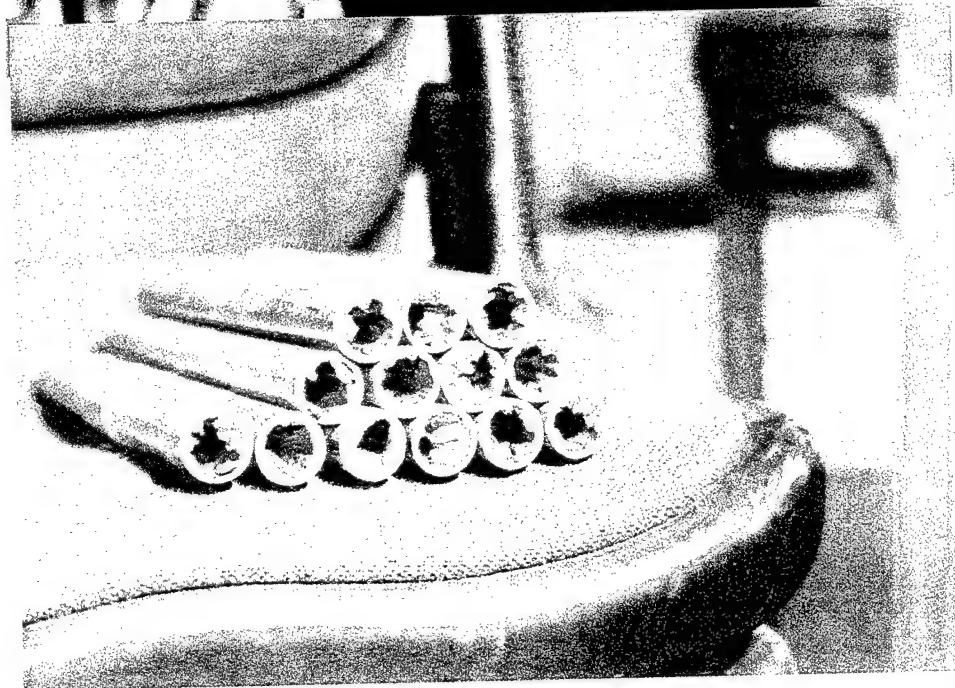
Figure
25

A 13-foot section of 3/4" hot water recirculating line from the far south end of the building was nearly obstructed by excessively thick paint. A pipe cutter was used to cut this pipe into 13 1-foot segments, and these are shown in Figure 25. The lining is not solid paint but is porous.

5. A critical error in this work was that dust from blasting was left in the hot water recirculating line at the south end of the building.
 - a) When paint was added, dust and paint combined to form a viscous paste which entrained air and formed an excessively-thick, poorly-adhering, porous crust. This was most severe in the hot water recirculating line at the south end of the building.

- b) In some locations an excessively thick porous lining was adjacent to uncoated pipe, indicating that paint mixed with blasting dust was thick and resistant to flow.

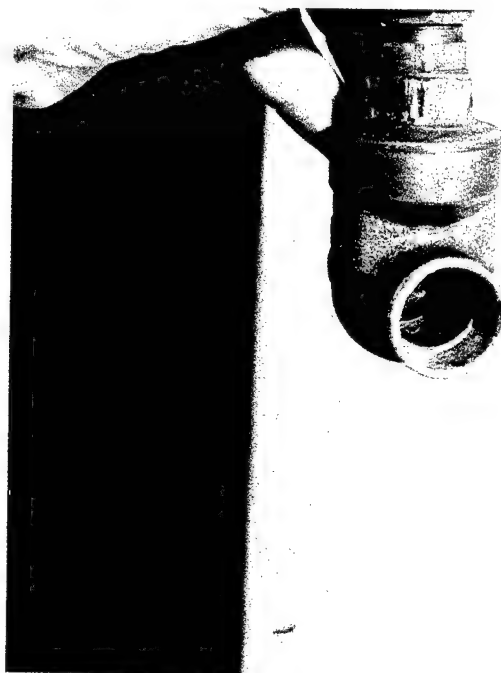
Figure 26 shows a valve from 3/4" hot water recirculating line which was not removed during painting. Paint covers the seat of the valve and prevents the valve from closing.

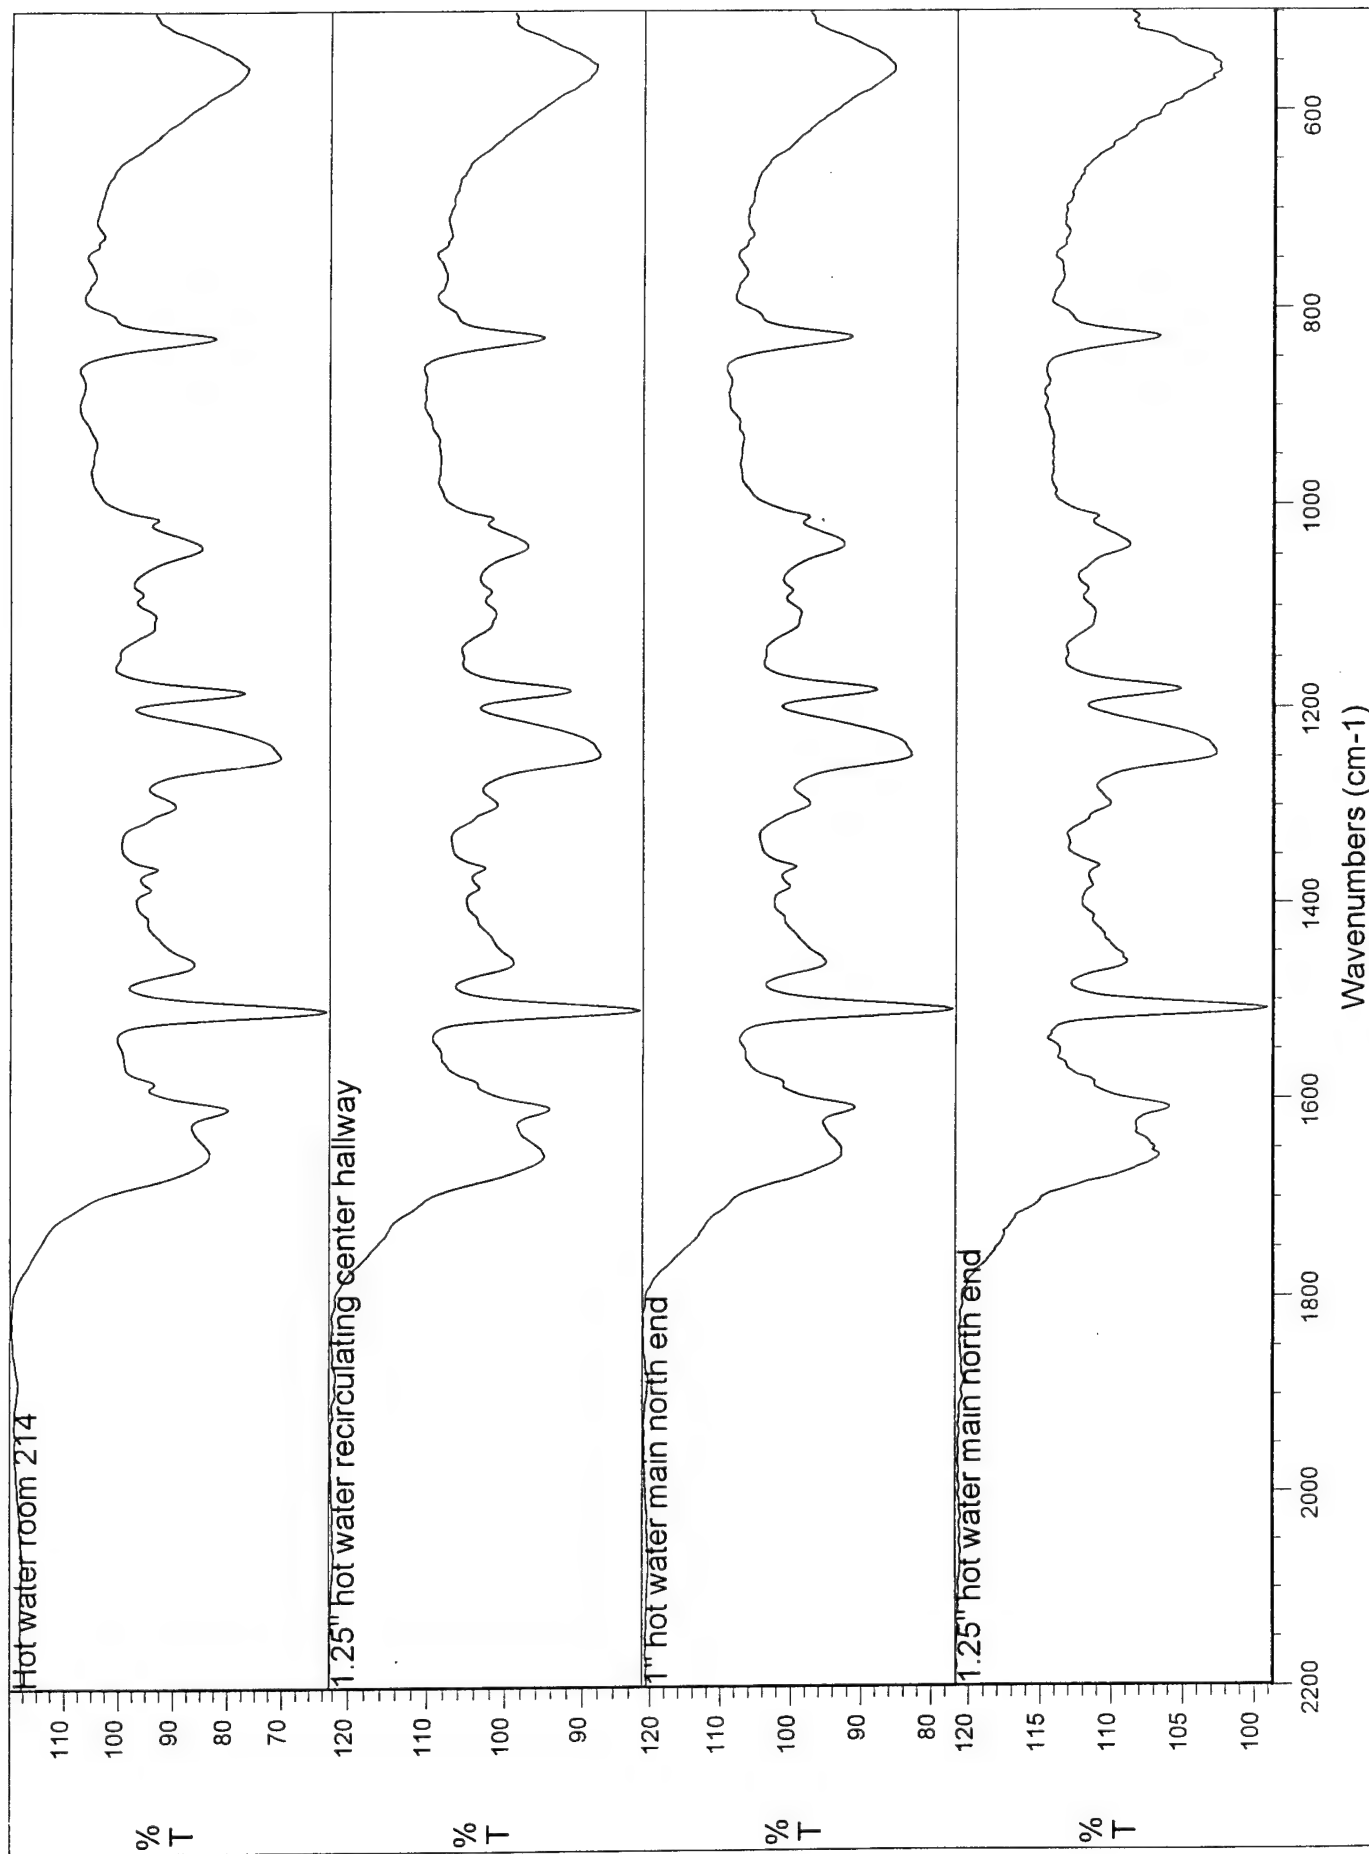
Manufacture and mixing of the lining. Infrared spectra of paint flakes were used to determine if the paint was manufactured properly and mixed properly. Figure 27 shows spectra of lining from four places in the building. The position and intensity of the peaks shows that the paint was properly manufactured and mixed.
